# Cappuccino Analysis Report

<b>Report Date:</b>	2025-06-09 21:10 UTC
<b>Images:</b>	3 uploaded
<b>Question Asked:</b>	Find rust on the metal

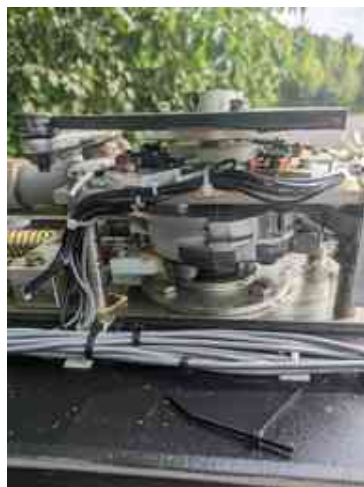
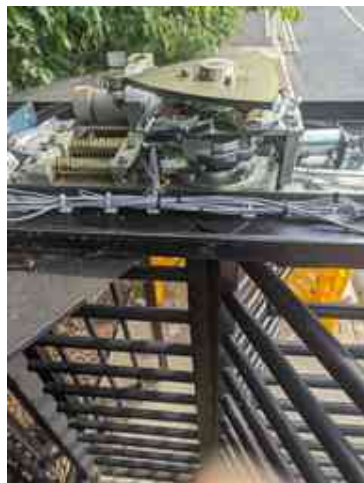
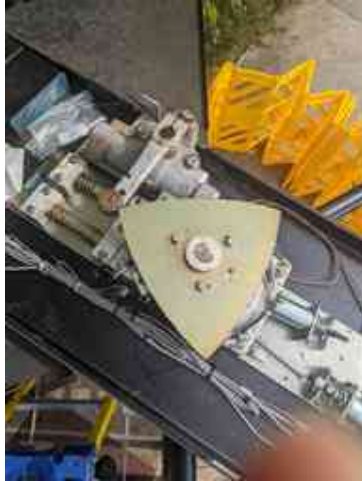
The images depict a complex mechanical assembly, likely part of an industrial or commercial machine, possibly related to motion control or automation systems. The assembly includes motors, gears, springs, and various mechanical linkages.

- Motors and Actuators**: There are several cylindrical motor units visible, which are likely servo or stepper motors given their size and integration into a precision assembly.
- Gearing System**: There are visible gears and possibly a worm drive, which suggests that this assembly is used for precise movement or positioning.
- Spring Mechanisms**: Coil springs are attached to some of the mechanical linkages, indicating tensioning functions or counterbalances.
- Linkages and Mounting Plates**: Metal linkages and triangular mounting plates are visible, which serve as structural components to hold various parts in alignment and transfer mechanical forces.

- Wire Bundles**: There are neatly organized wire bundles secured with cable ties, indicating a well-maintained system. These wires likely carry power and control signals to the motors and sensors.
- Electrical Connectors**: The connectors are not clearly visible, but the organization of the wires suggests they terminate in standard industrial connectors for easy maintenance and modularity.

- **Visible Rust**: There is noticeable rust on some of the metallic components, particularly on the springs and some screws. This suggests exposure to moisture or a lack of protective coating in these areas.
- **Potential Impact**: Rust can lead to mechanical wear and degradation of strength in the affected components, potentially leading to mechanical failure if not addressed.

1. **Rust Treatment**: Apply a rust remover or converter on affected parts, followed by a protective coating to prevent further corrosion.
2. **Regular Inspection**: Schedule regular maintenance checks to inspect for signs of wear and corrosion, especially since the assembly includes critical moving parts.
3. **Lubrication**: Ensure all moving parts are adequately lubricated to reduce wear and prevent rust.

The assembly appears to be part of a larger system with critical mechanical functions. The presence of rust needs immediate attention to prevent further damage. Regular maintenance and protective measures are recommended to ensure the longevity and proper functioning of the system.
