Cappuccino Analysis Report

Visual Analysis and Troubleshooting for Telescopic Sliding Door SLX

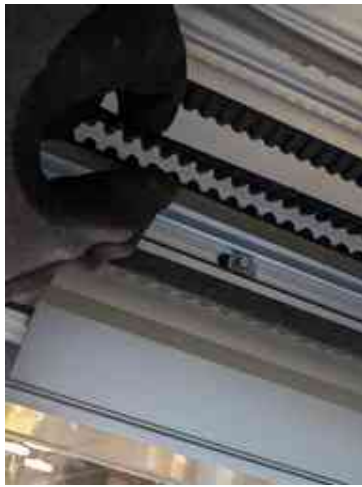
Image 1: 8193.jpg

- The belt appears to be a toothed timing belt, which is crucial for the precise movement of the telescopic sliding door.
- The belt is tightly installed, as indicated by the difficulty in overlapping and the vibration when plucked. This suggests high tension, which could be causing excessive stress on the belt and associated components.

- **Belt Tension**: Excessive tension can lead to premature wear and tear of the belt and the motor bearings. It can also cause the belt to vibrate when plucked, as noted. This vibration is an indicator that the belt may be too tight or that there is an alignment issue with the pulleys or the track.

1. **Adjust Belt Tension**: If the belt is too tight, it should be loosened slightly to fall within the recommended tension range. This adjustment can help reduce the vibrations and extend the life of the belt and motor.
2. **Alignment Check**: Ensure that the belt and all associated pulleys and tracks are properly aligned. Misalignment can lead to inefficient operation and increased wear.
3. **Regular Maintenance**: Implement a regular maintenance schedule to check the condition and tension of the belt, along with the alignment and lubrication of the mechanical system.

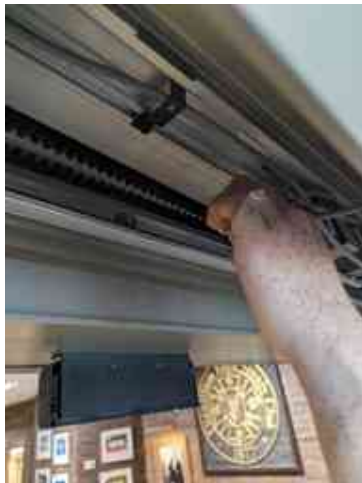
Image 2: 8192.jpg

- The belt runs through a track system, which is part of the door's mechanical drive system. Proper alignment and lubrication of this track are essential for smooth operation.
- The presence of a hand adjusting or checking the belt tension in the second image suggests recent manual intervention, possibly for maintenance or troubleshooting.
